4. TITLE (and Subtitle) Phase I Inspection Report National Dam Safety Program. Stony Brook Watershed Dam Site 7 (NJ00344), Mercer County, New Jersey, Raritan River Basin, Stony Brook, Mercer County, New Jersey. Phase I Inspection Report.		5. TYPE OF REPORT & PERIOD COVERED (9) FINAL rept. 7

6. PERFORMING ORGANIZATION NAME AND ADDRESS Storch Engineering 220 Ridgedale Ave. Florham Park, N.J. 07932		7. CONTRACT OR GRANT NUMBER(s) DACW61-79-C-0011

OVERVIEW - STONY BROOK WATERSHED SITE NO. 7 DAM

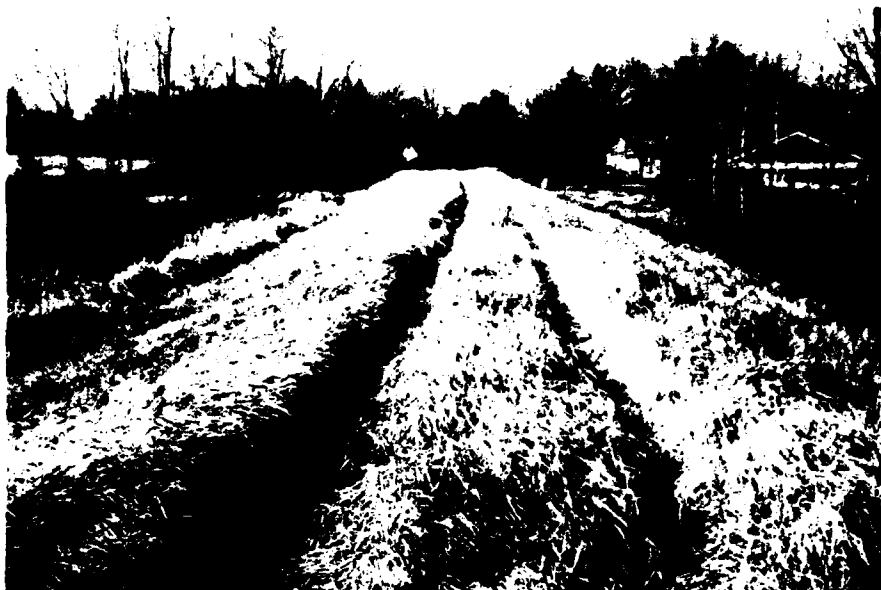
PHOTO 5
CREST OF DAM

The earthfill embankment crest is straight and approximately level. There were two well defined vehicle tire paths extending along the entire embankment crest. The tire path areas exhibited a good stand of grass indicating infrequent traffic. There were no signs of subsidence or distress and the overall embankment was covered with moderate height, dense, hardy grass. No woody growth was observed on the embankment.

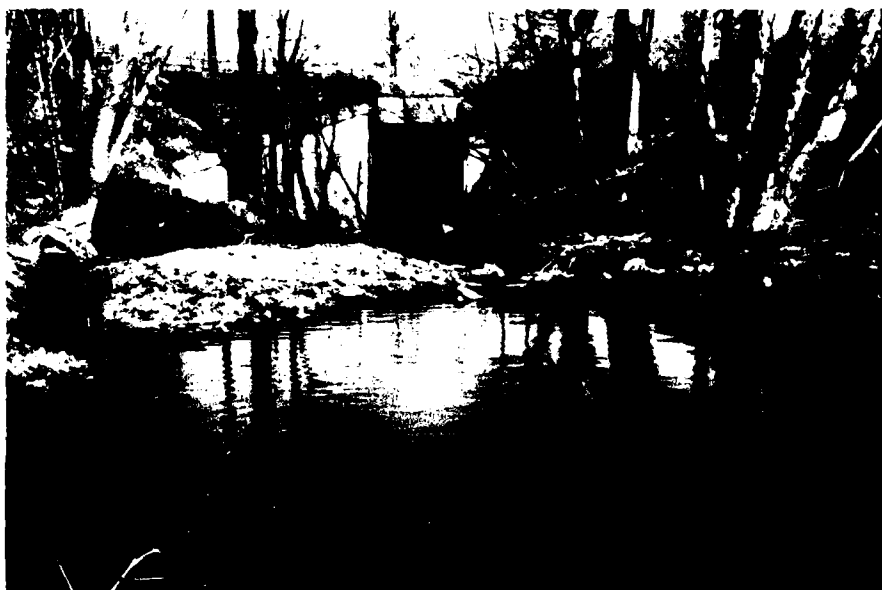
PHOTO 10

CULVERT UNDER ROAD DOWNSTREAM FROM DAM
